JOB NO. 43-0033.283.01

UNION RESERVOIR
BORROW AREA LOCATION MAP

UNION RESERVOIR
TYPICAL DAM SECTIONS

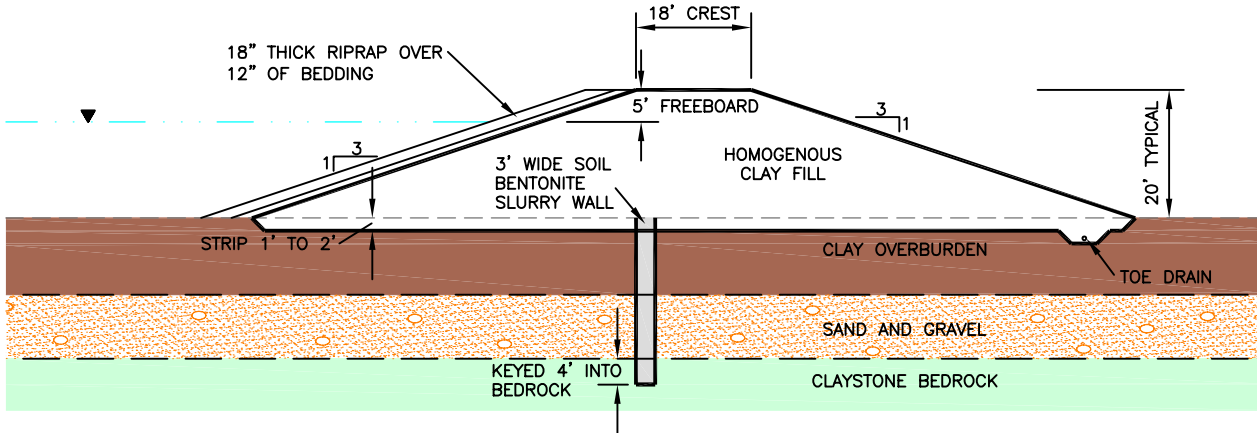
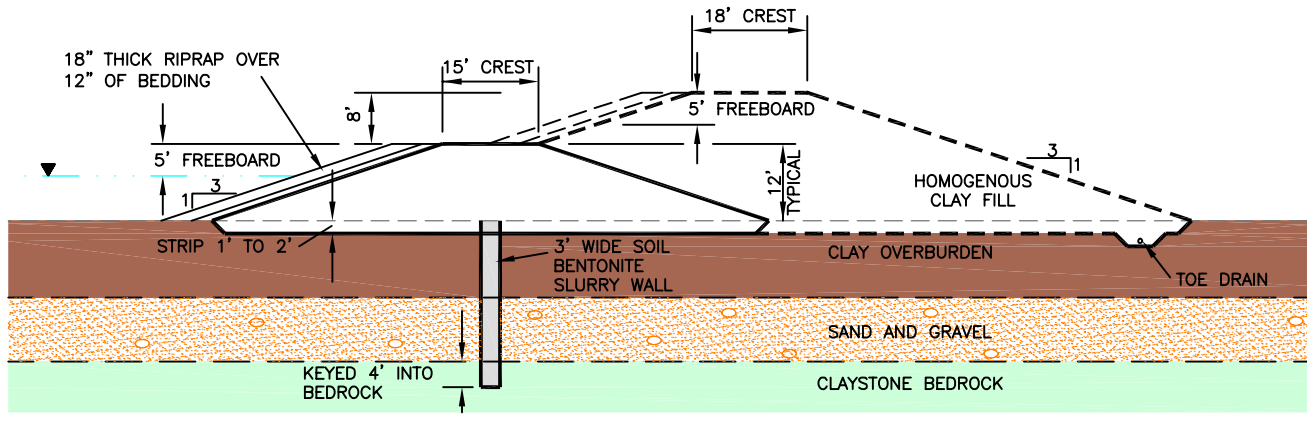
RMC
FIGURE:
5.2

13 FOOT RESERVOIR RAISE

**5 FOOT RESERVOIR RAISE WITH FUTURE
DOWNSTREAM ENLARGEMENT TO 13 FEET**

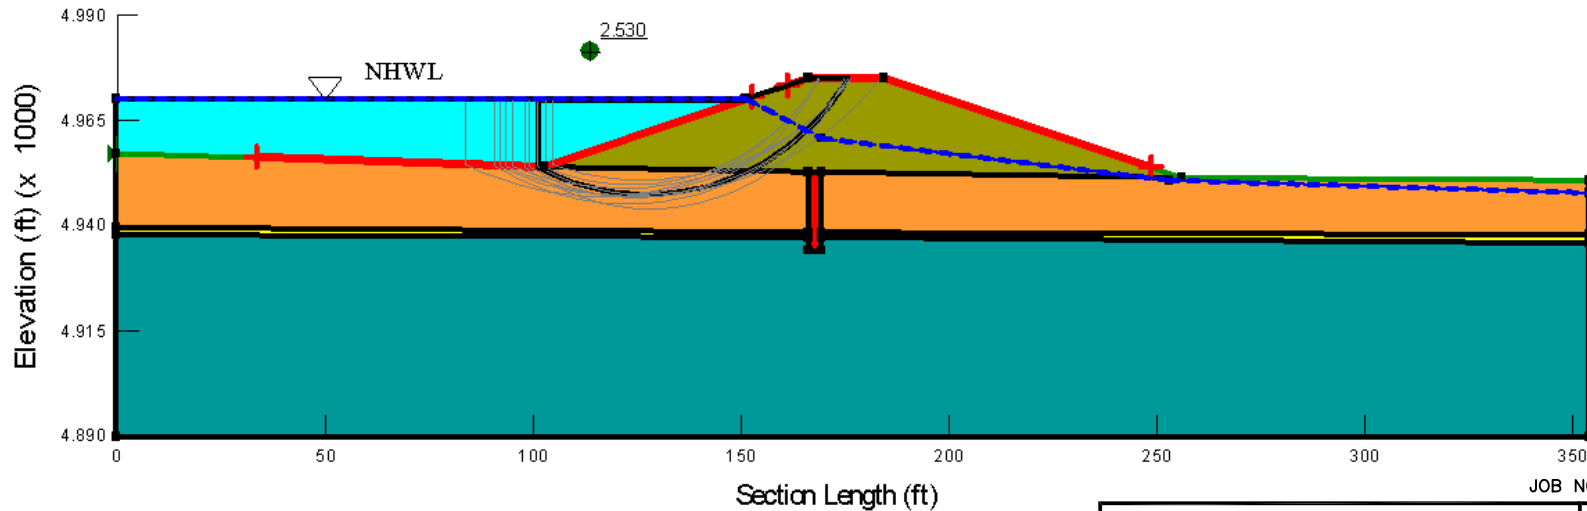
FIGURE:
5.3

Union Reservoir Station 59+74 NHWL Upstream Slope

- Description: Bedrock (Fully Softened)
Wt: 110
Cohesion: 0
Phi: 26
- Description: Sand & Gravel
Wt: 120
Cohesion: 0
Phi: 35
- Description: Overburden
Wt: 106
Cohesion: 50
Phi: 26
- Description: Embankment
Wt: 106
Cohesion: 150
Phi: 28
- Description: Slurry Wall
Wt: 115
Cohesion: 0
Phi: 22
- Description: Water
Wt: 62.4

Spencer Factor of Safety: Factor of Safety: 2.530

UNION RESERVOIR
SLOPE STABILITY ANALYSIS
STATION 59+74

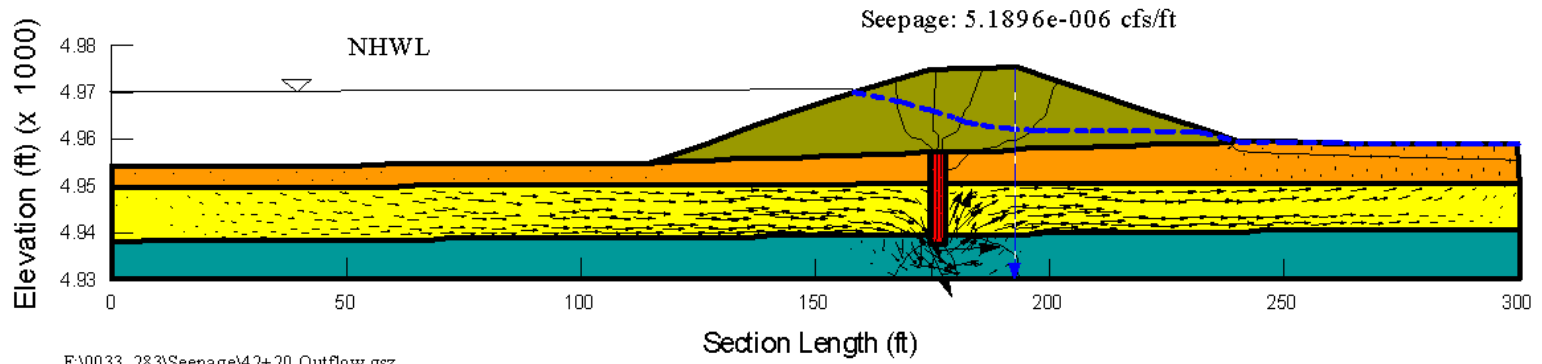
FIGURE:

Union Reservoir Slurry Wall Option

- Bedrock, $K = 3.29e-05$ cm/sec
- Sand & Gravel, $K = 1.40e-02$ cm/sec
- Overburden, $K = 7.99e-06$ cm/sec
- Embankment, $K = 3.29e-07$ cm/sec
- Slurry Wall, $K = 1.00e-07$ cm/sec

UNION RESERVOIR
SEEPAGE ANALYSIS
STATION 42+20
