UNION RESERVOIR
 SUMMARY LOGS OF 2004
 EXPLORATORY BORINGS
 WEST SIDE OF LAKE

JOB NO. 19-0033.283.00

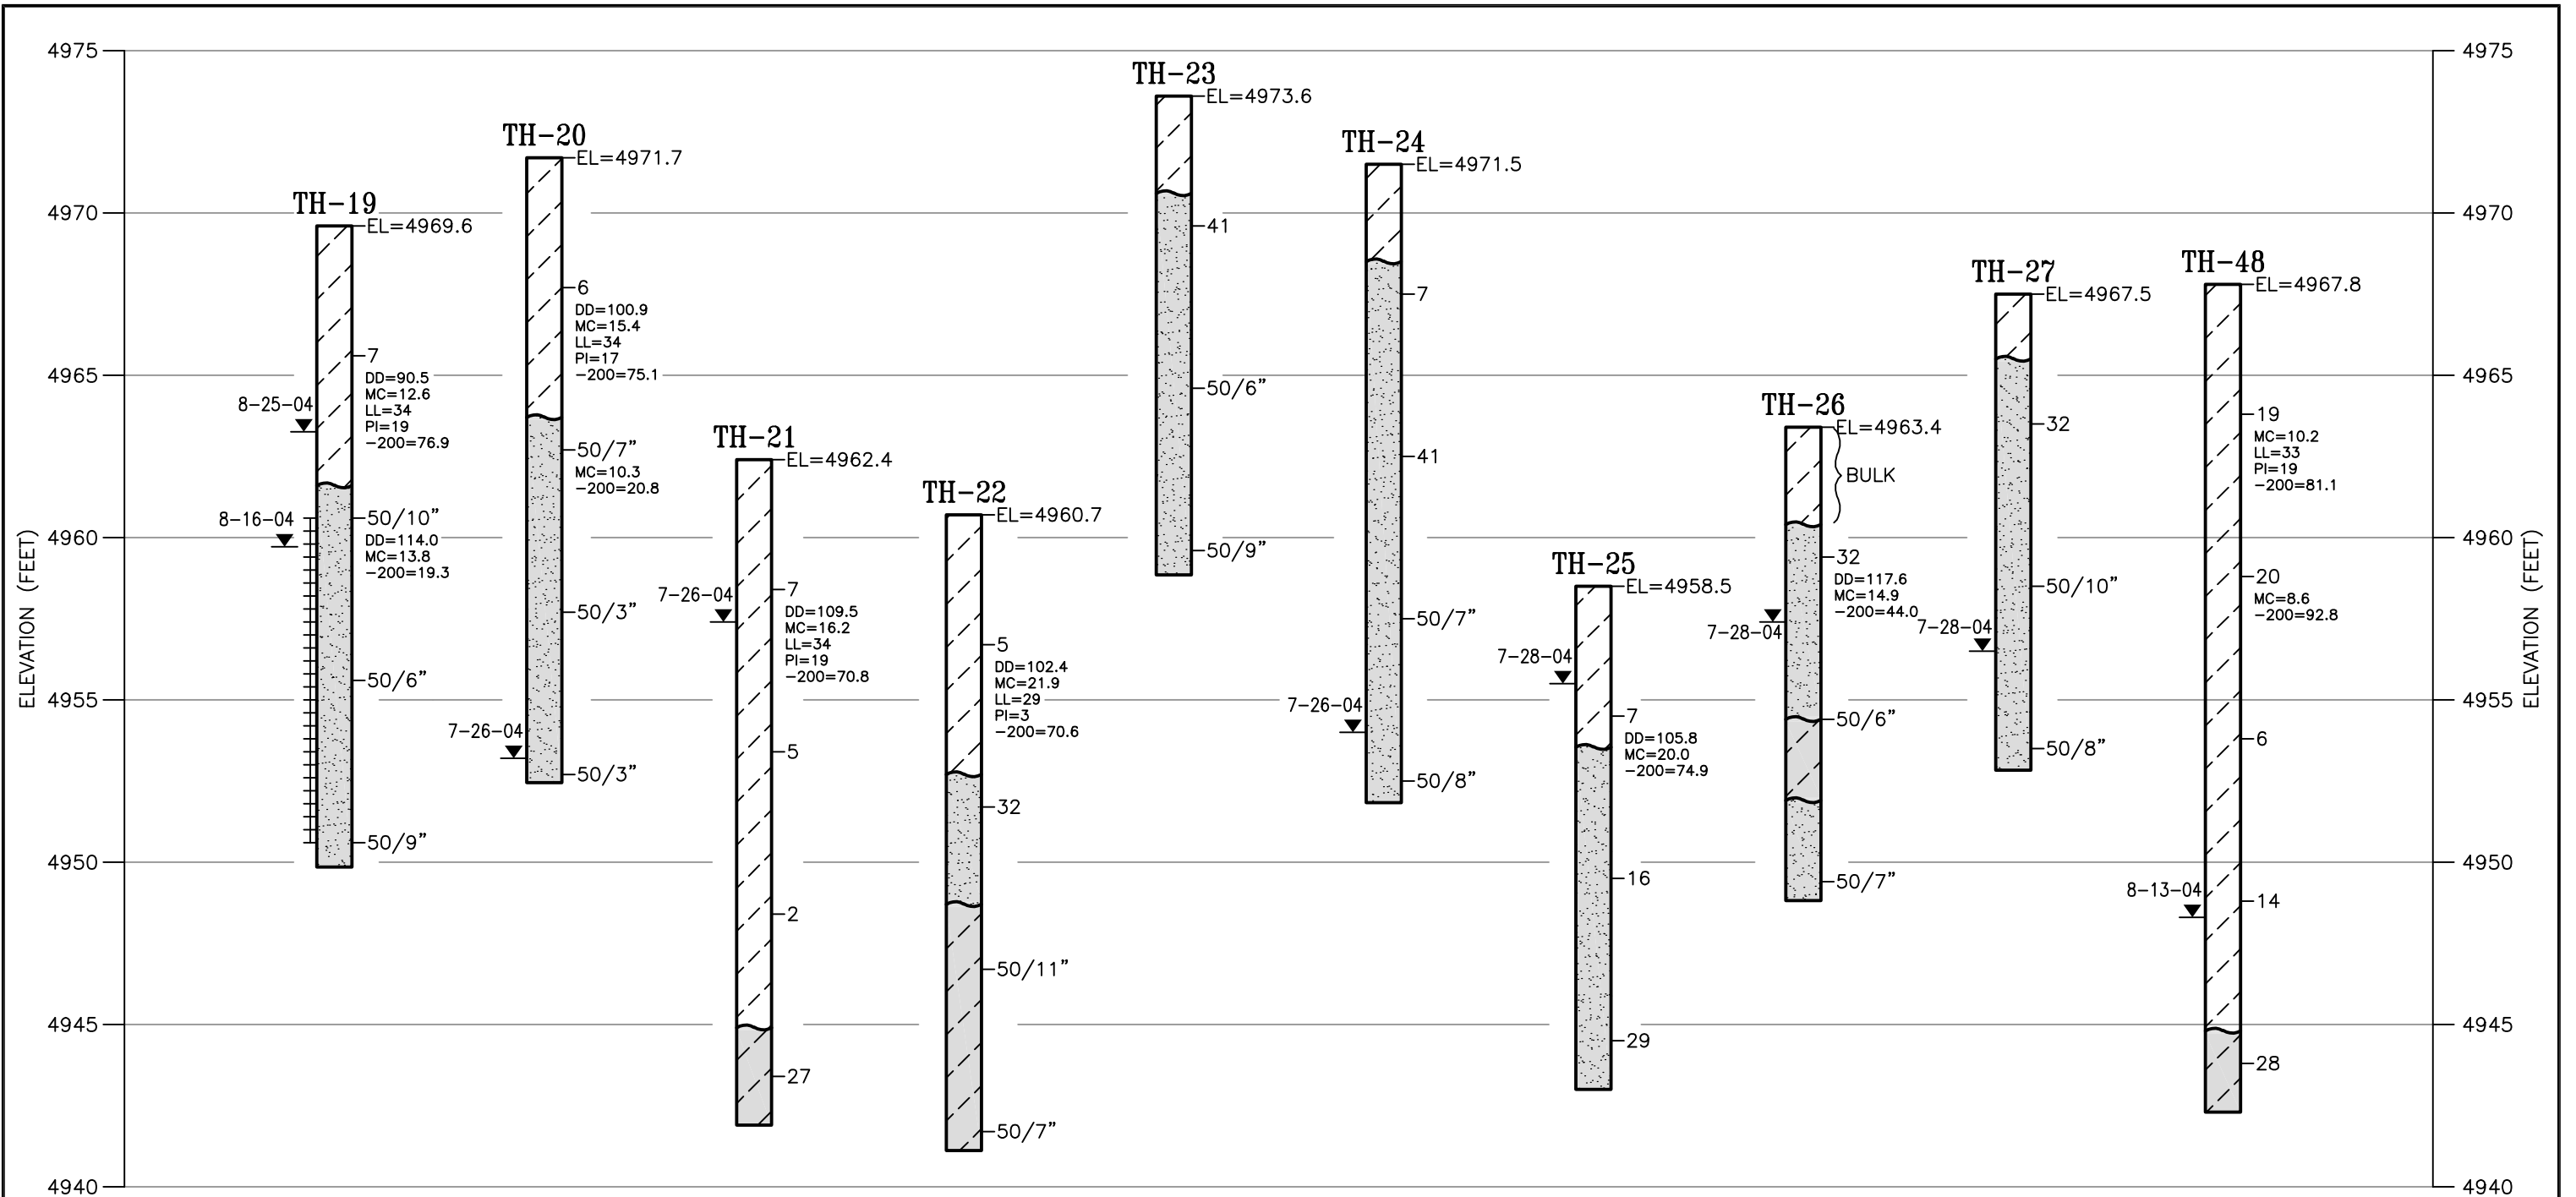
FIGURE:
3.8

UNION RESERVOIR
SUMMARY LOGS OF 2004
EXPLORATORY BORINGS
EAST SIDE OF LAKE

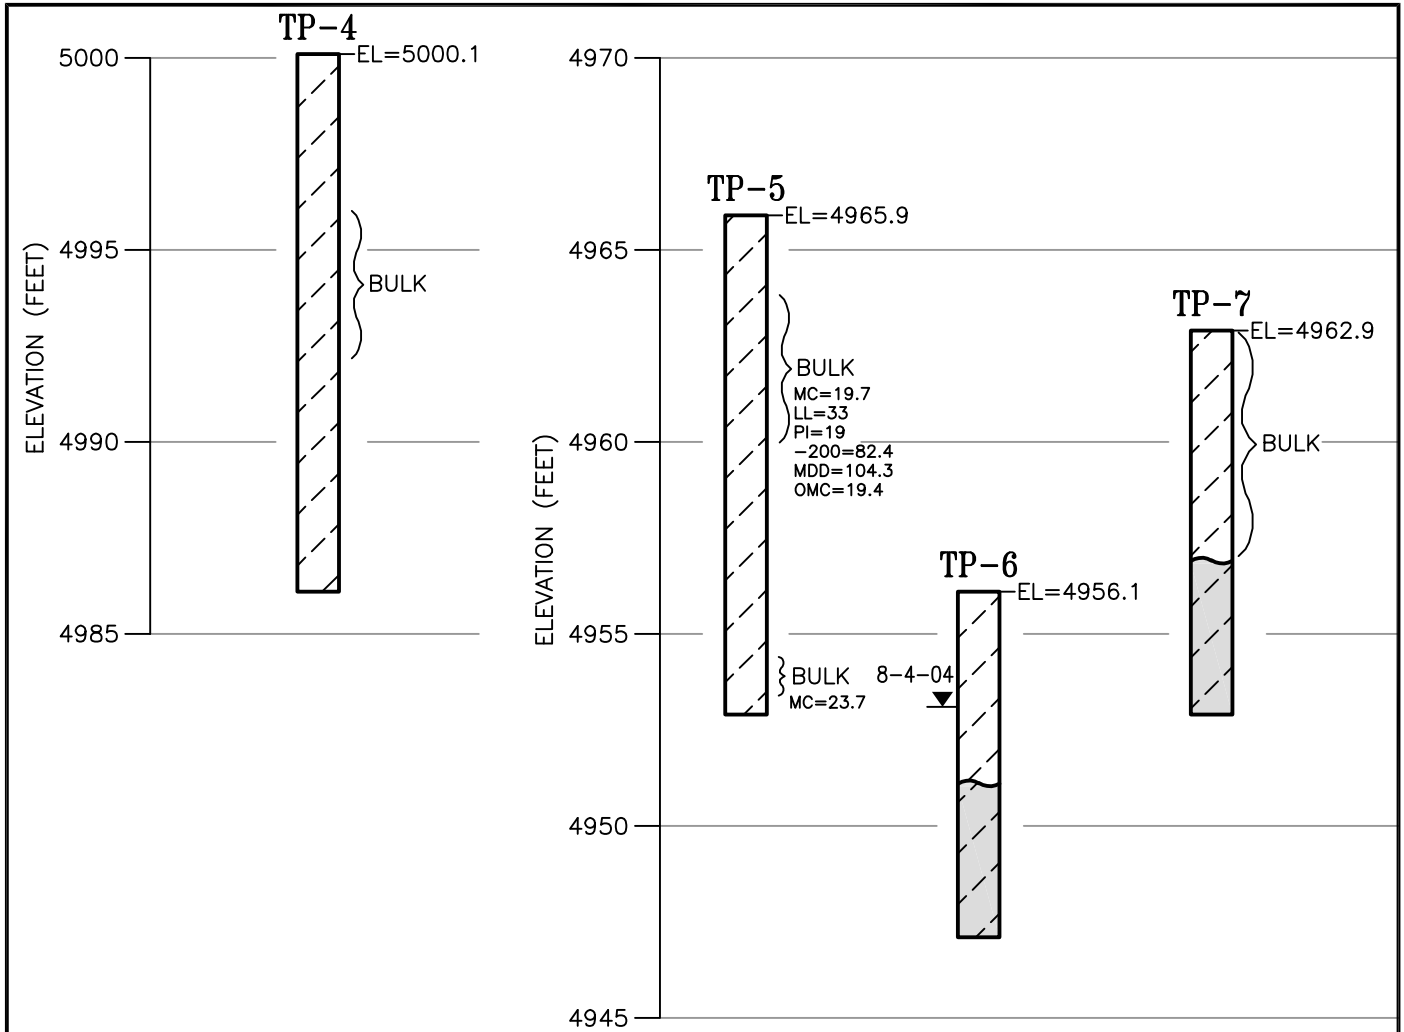
3.9

UNION RESERVOIR
SUMMARY LOGS OF 2004
EXPLORATORY TEST PITS
EAST SIDE OF LAKE
